**ON-SITE AIR BAG INVESTIGATION**

**CASE NO. - 94-11**  
**FLEET - RENTAL VEHICLE**  
**LOCATION - [REDACTED] INDIANA**  
**ACCIDENT DATE - [REDACTED] 1994**

**Contract Number: DTNH22-94-D-17058**

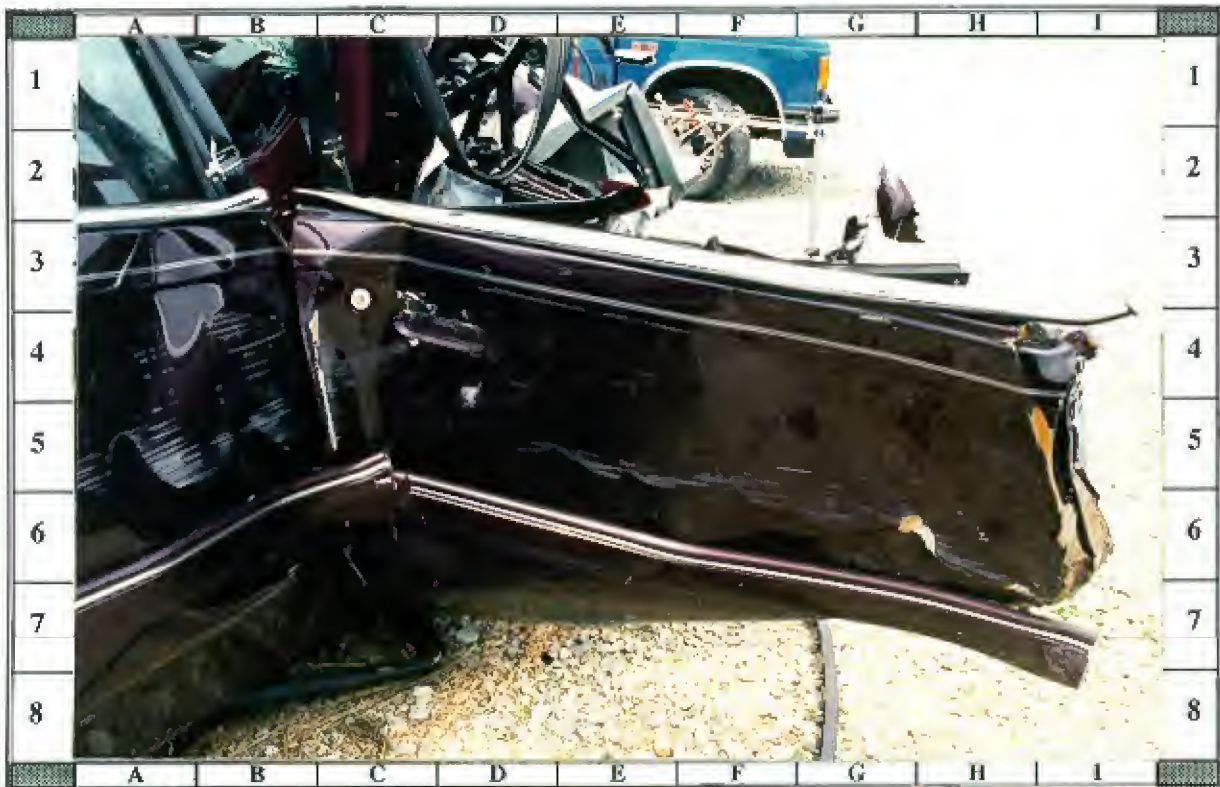
# 45 -- Close-up of swiping damage to 1994 Oldsmobile Cutlass Ciera S's right front door panel from sign post impact (3rd)

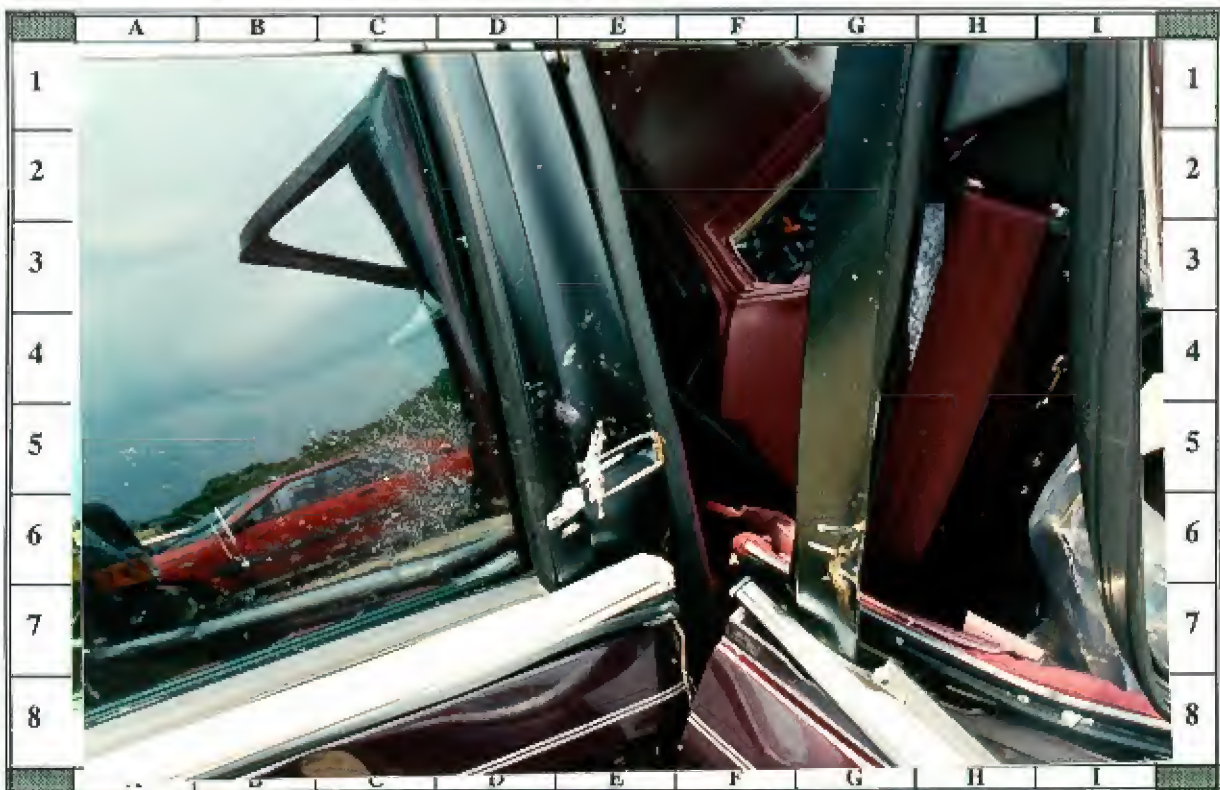
# 46 -- Scratches to 1994 Oldsmobile Cutlass Ciera's right B-pillar and rear of RF & front of RR window frames from mailbox impact (1st)

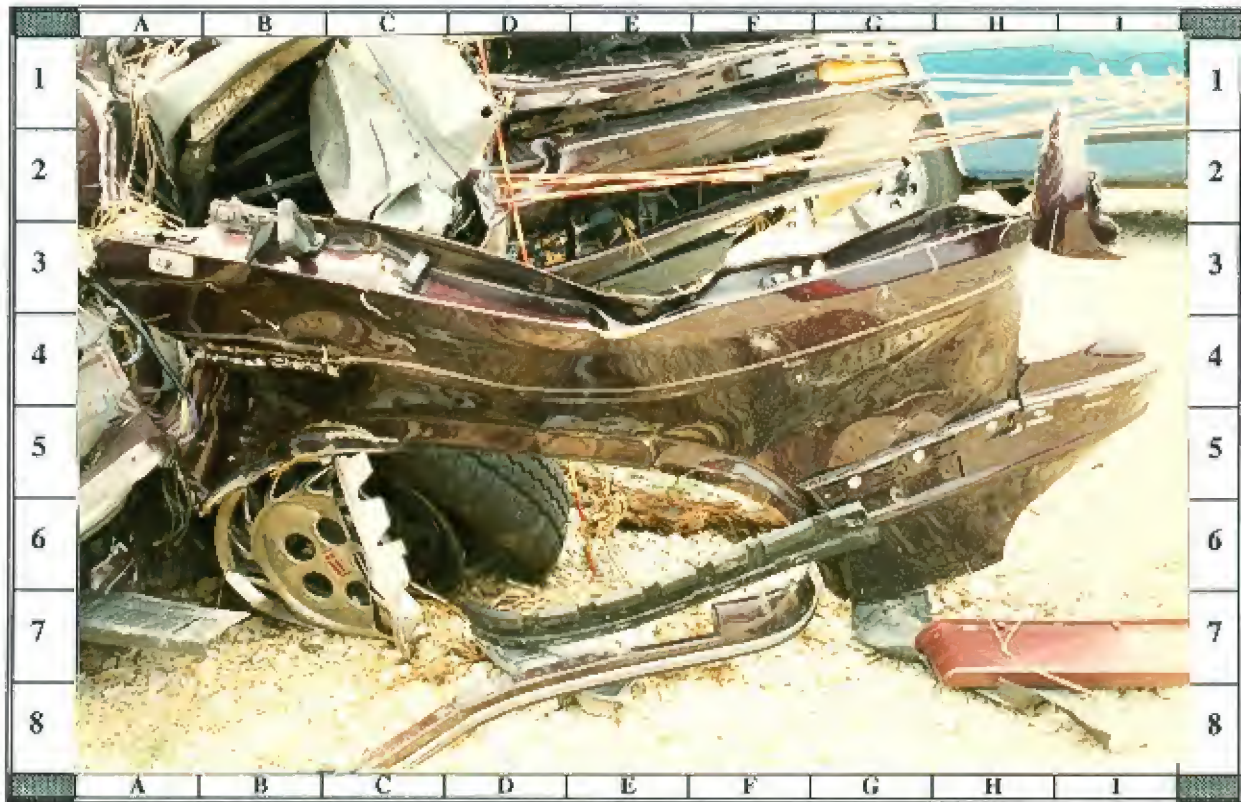
# 47 -- Close-up of damage to '94 Cutlass Ciera's right fender, wheel, rim, and wheel cover; NOTE: vertical rod represents max crush"

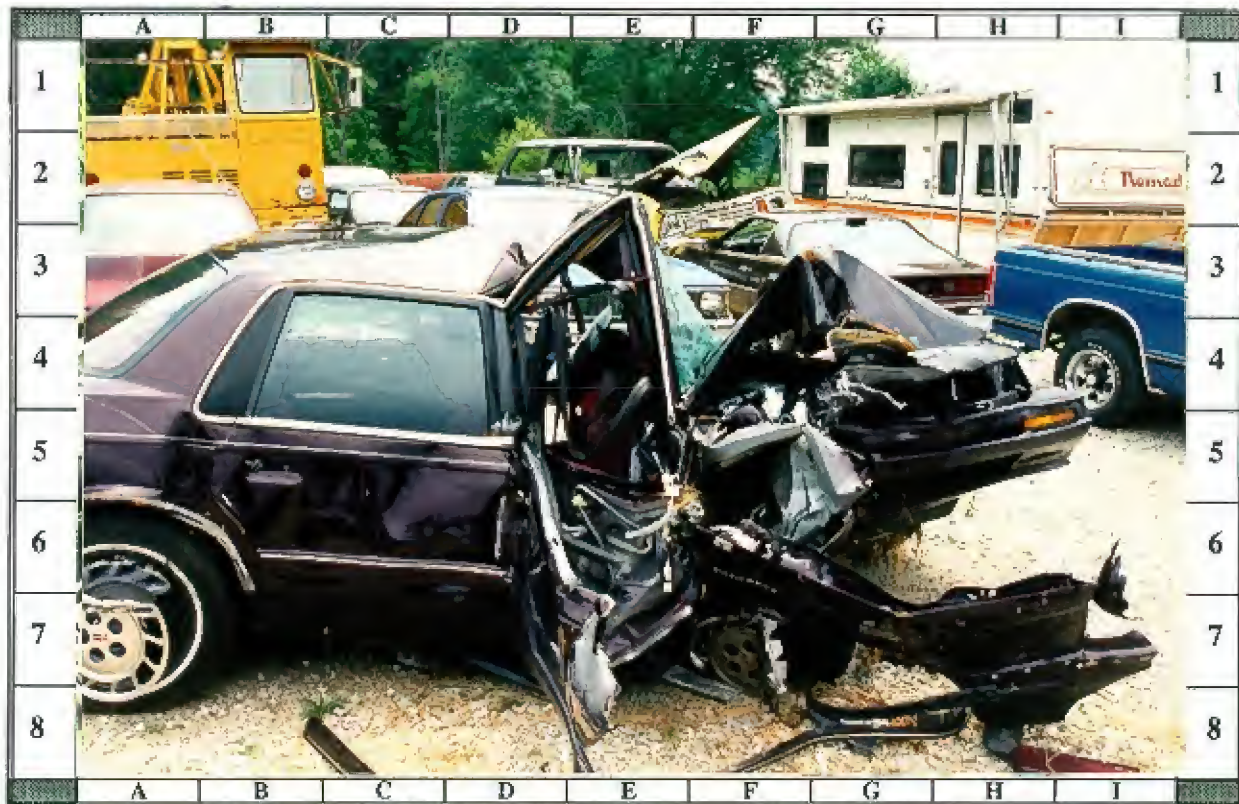
# 48 -- 1994 Oldsmobile Cutlass Ciera S viewed from right showing extensive frontal crush and intrusion at the right A-pillar area

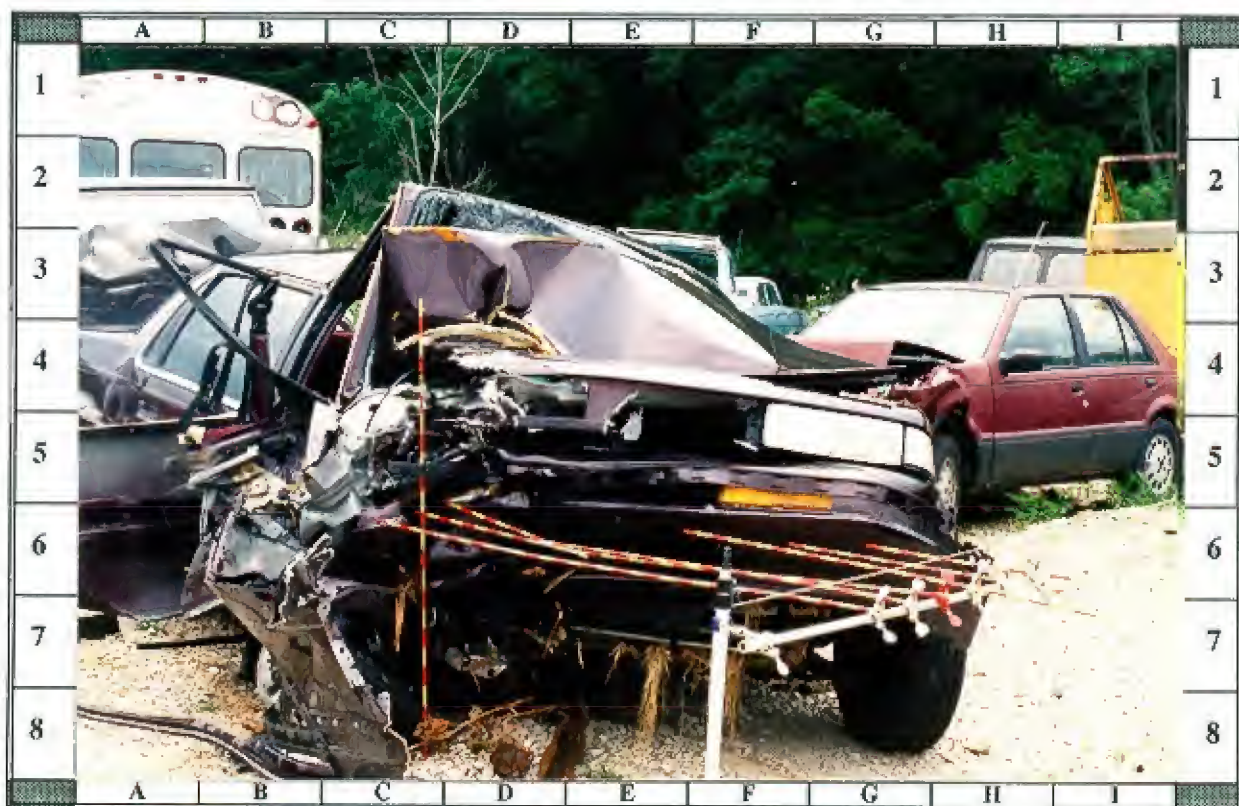
# 49 -- 1994 Oldsmobile Cutlass Ciera viewed from front right with contour gauge set-up; NOTE: vertical rod & frontal rightward shift

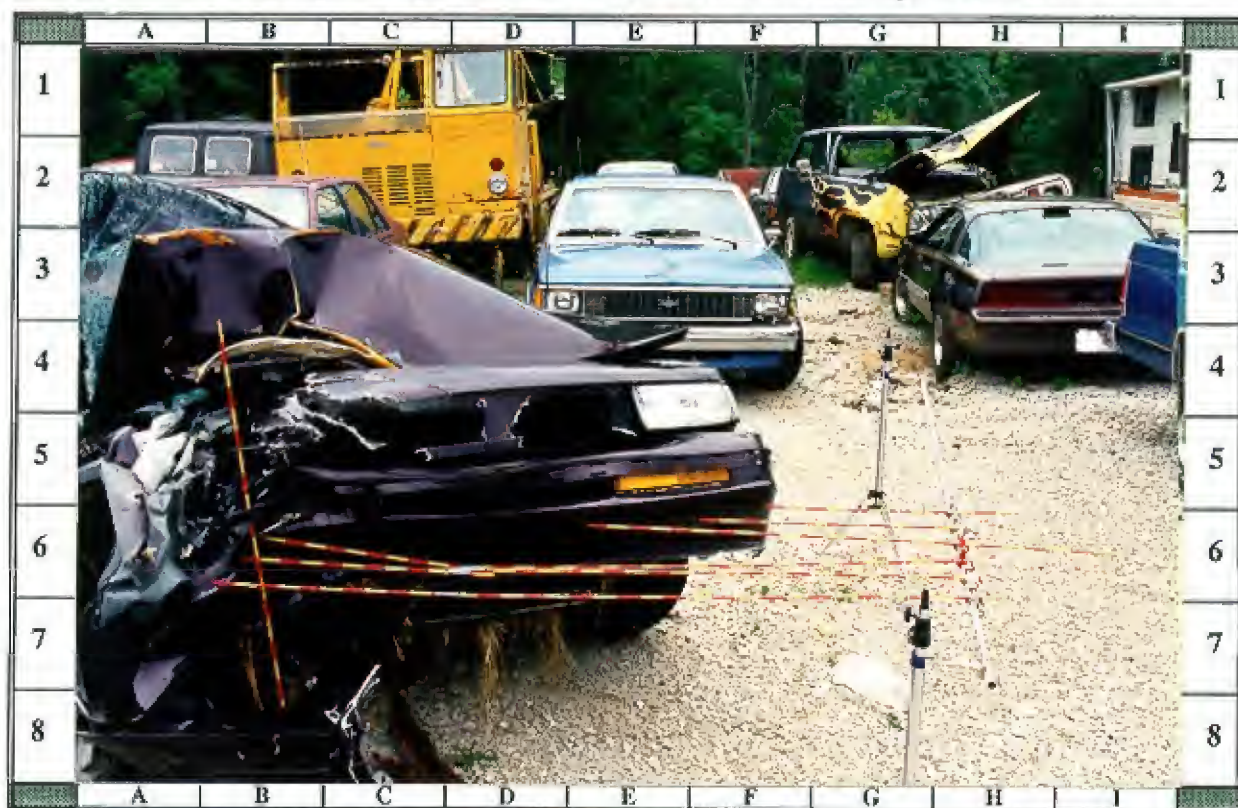
# 50 -- 1994 Oldsmobile Cutlass Ciera S's front crush with contour gauge viewed across reference line from right; NOTE: vertical rod

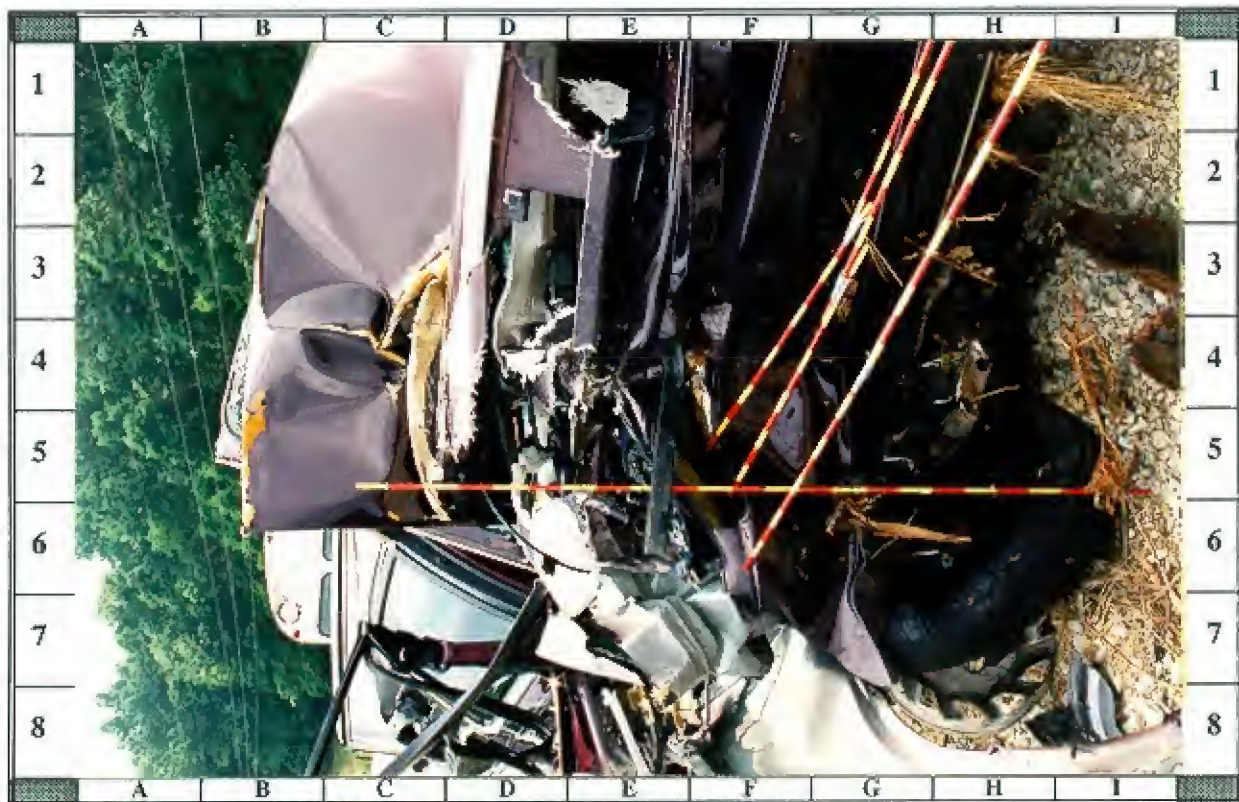
# 51 -- Close-up of 1994 Oldsmobile Cutlass Ciera S's direct damage at front right corner (i.e., area of maximum crush)

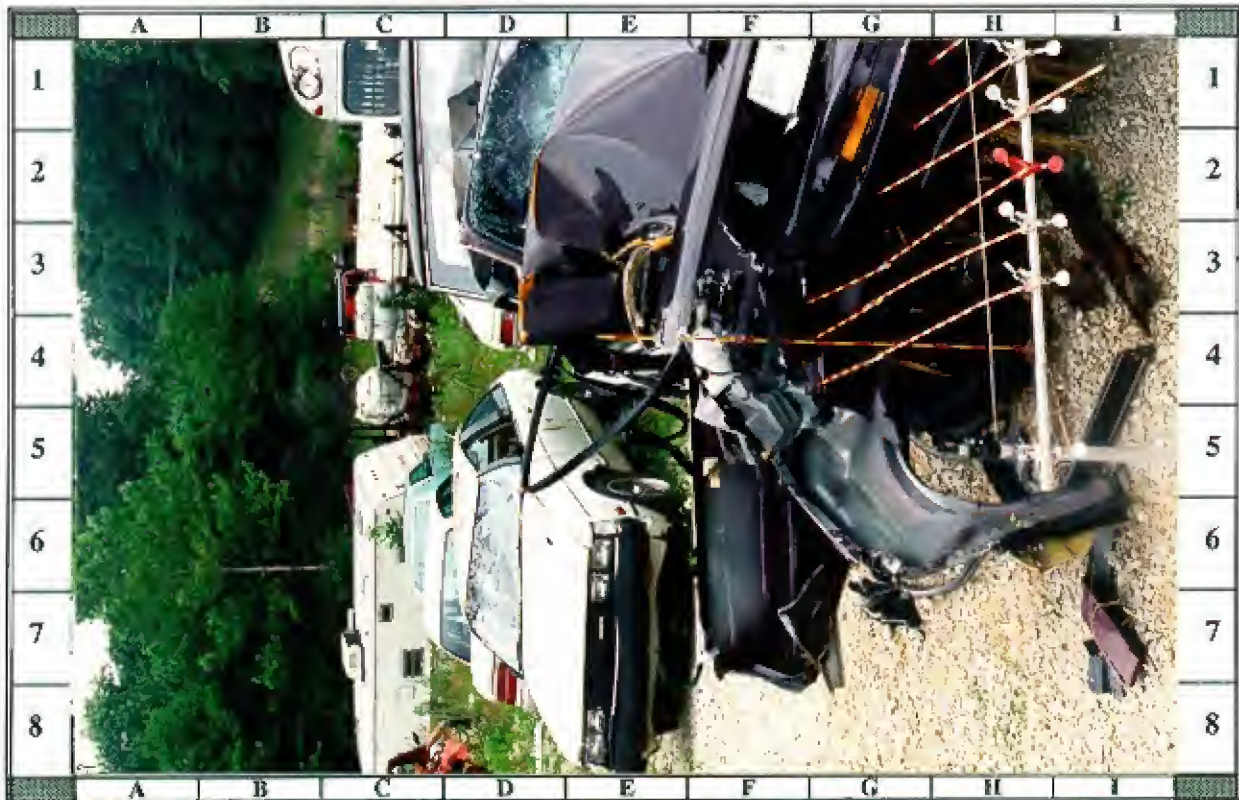
# 52 -- 1994 Oldsmobile Cutlass Ciera viewed from front along right side showing pulled out R fender & door panel; NOTE: vertical rod

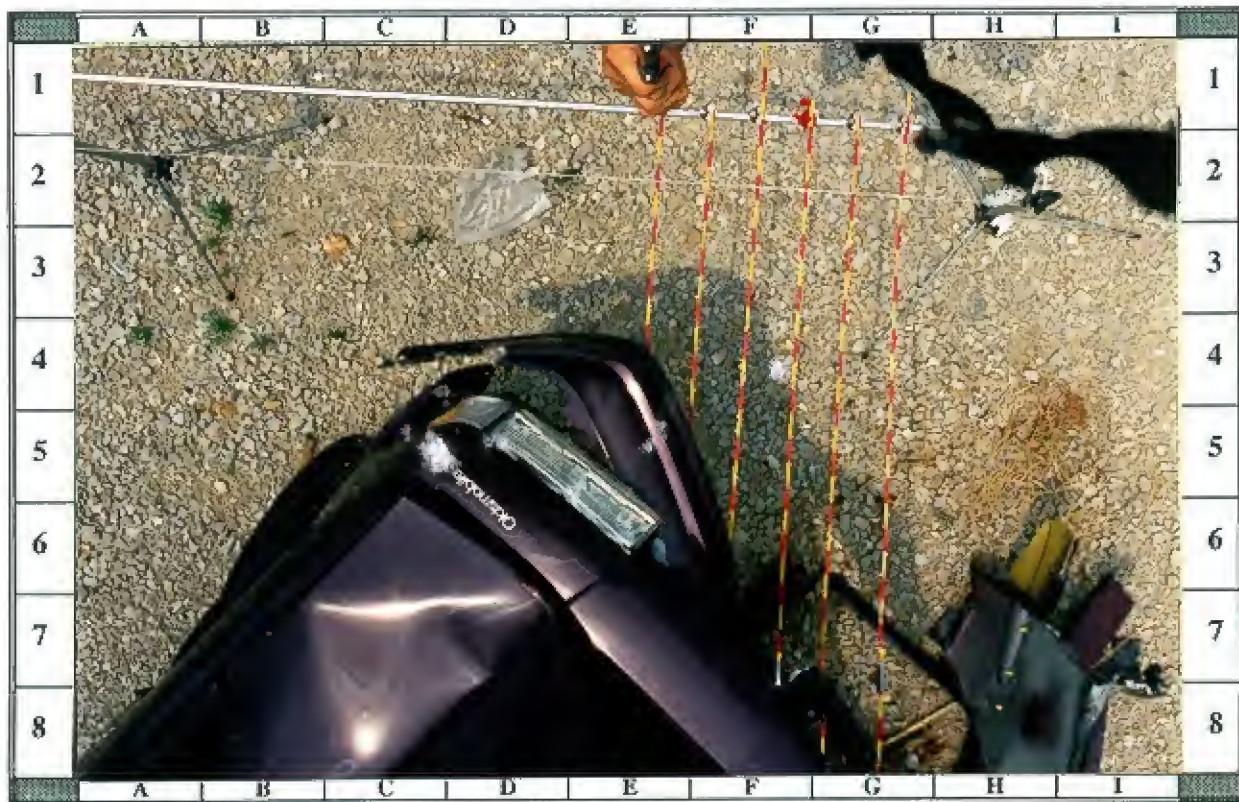
# 53 – Front right overhead view of front right crush to '94 Oldsmobile Cutlass Ciera S from large tree (~37 cm) impact; NOTE: field L

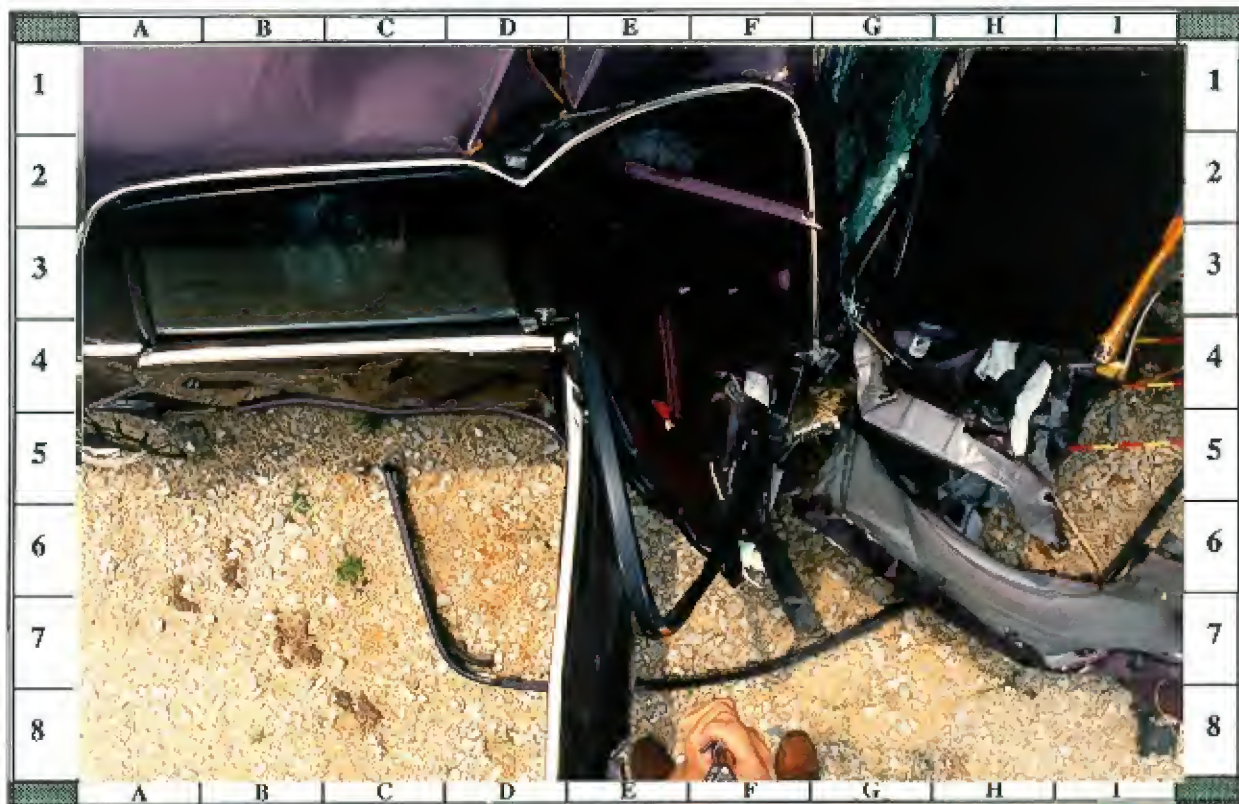
# 54 – Right passenger overhead view of FR crush to '94 Oldsmobile Cutlass Ciera showing induce damage to R A-pillar, roof, & door

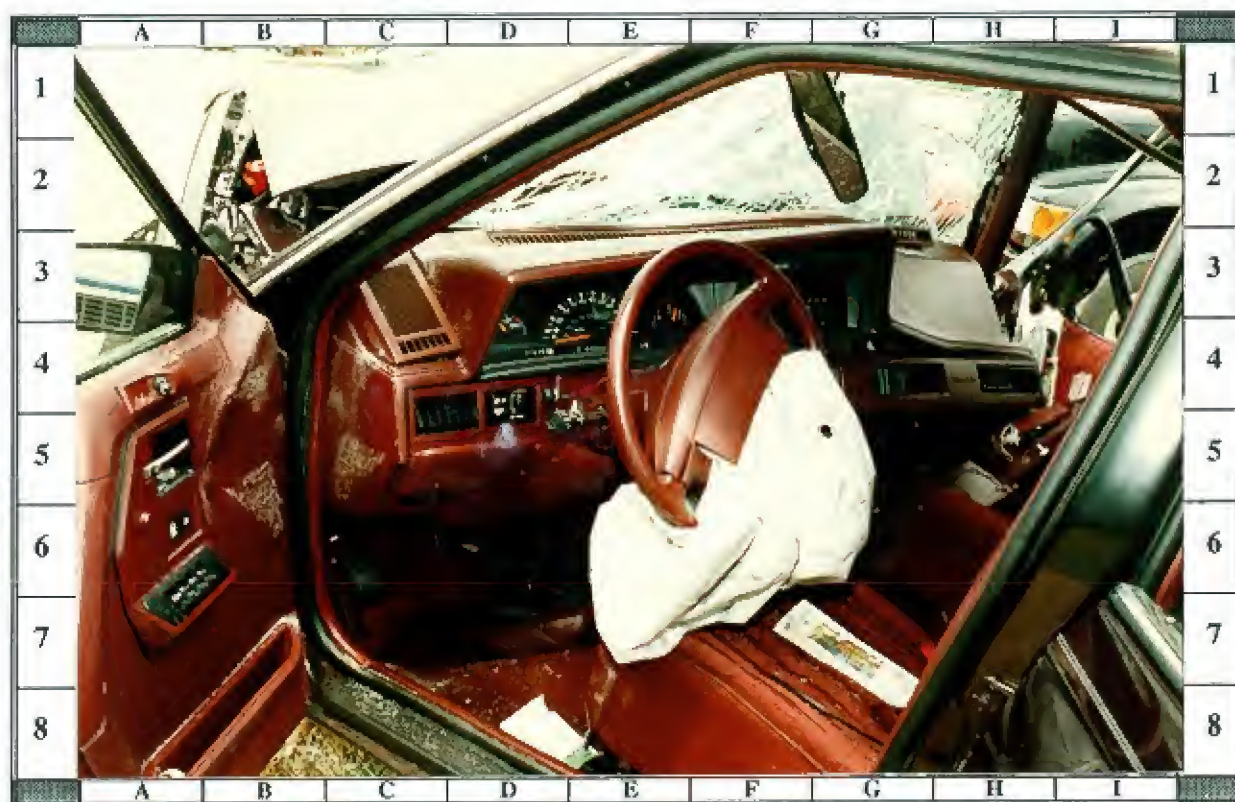
# 55 -- Driver's area of 1994 Oldsmobile Cutlass Ciera showing deployed air bag and extensive intrusion into right front occupant space

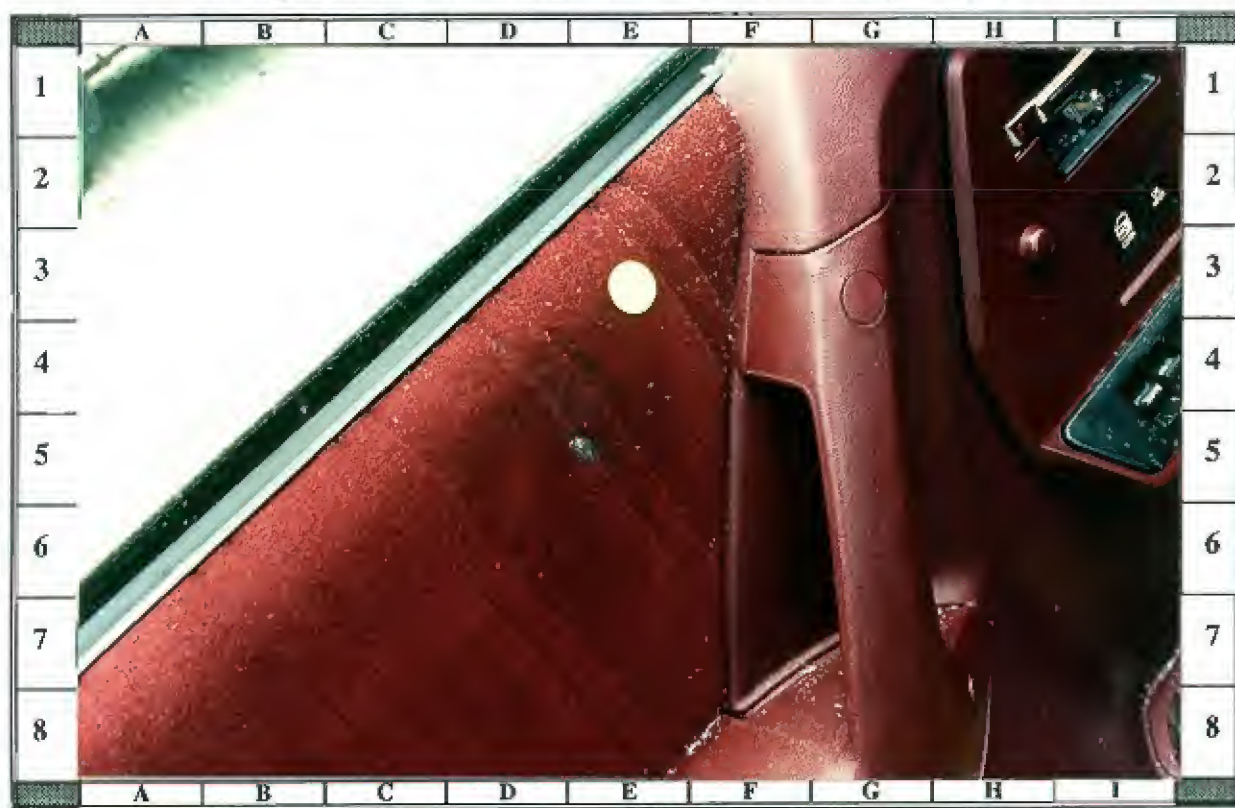
# 56 -- Close-up of dried blood smear on interior surface of 1994 Oldsmobile Cutlass Ciera S's driver door

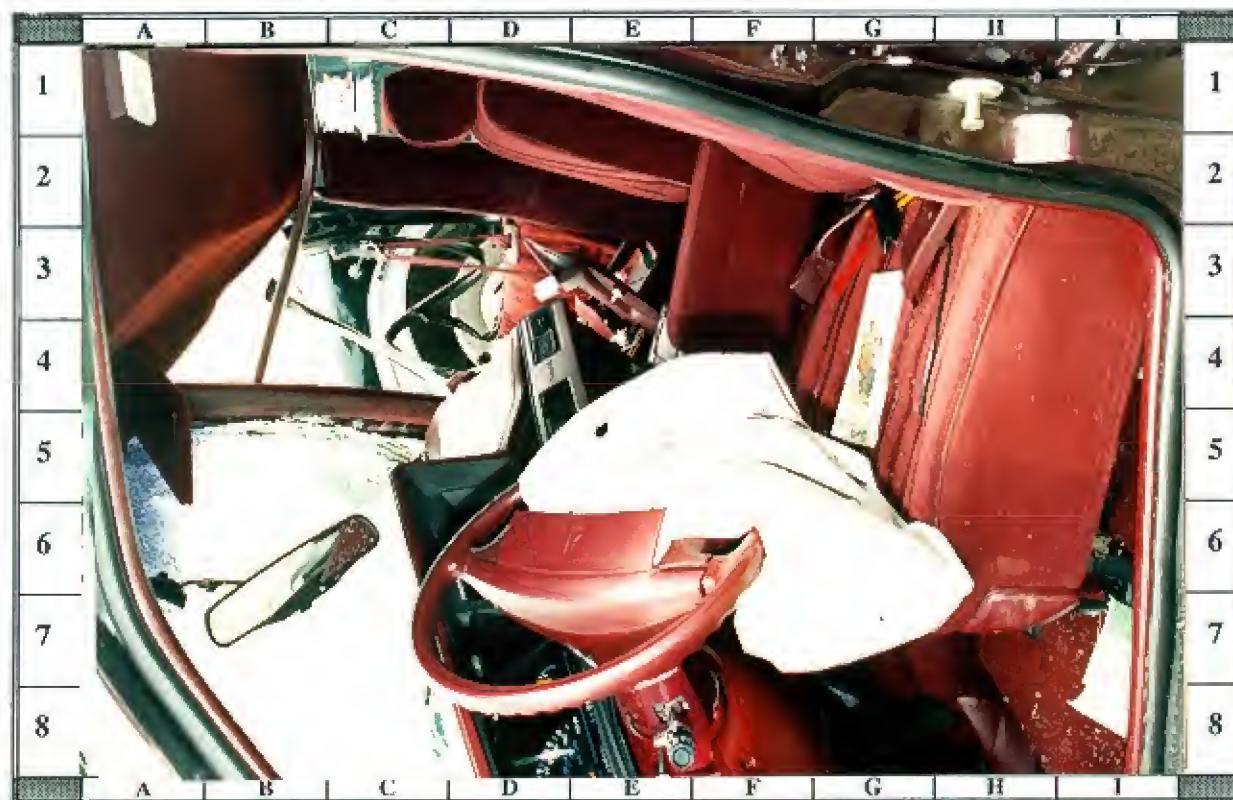
# 57 -- Front passenger seating area of 1994 Oldsmobile Cutlass Ciera S showing deployed air bag & intrusion of right dash into RF space

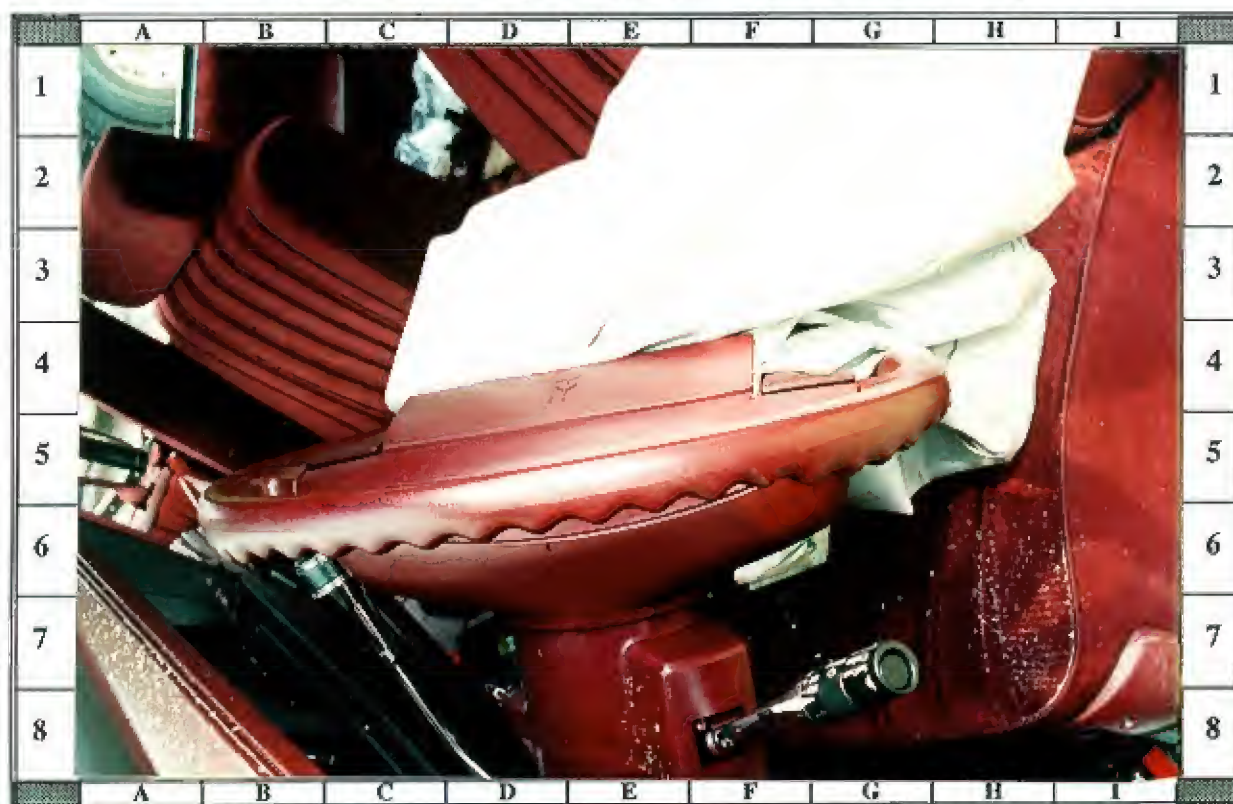
# 58 -- Left side view of undeformed driver's steering wheel in 1994 Oldsmobile Cutlass Ciera; NOTE: extensive right dash intrusion

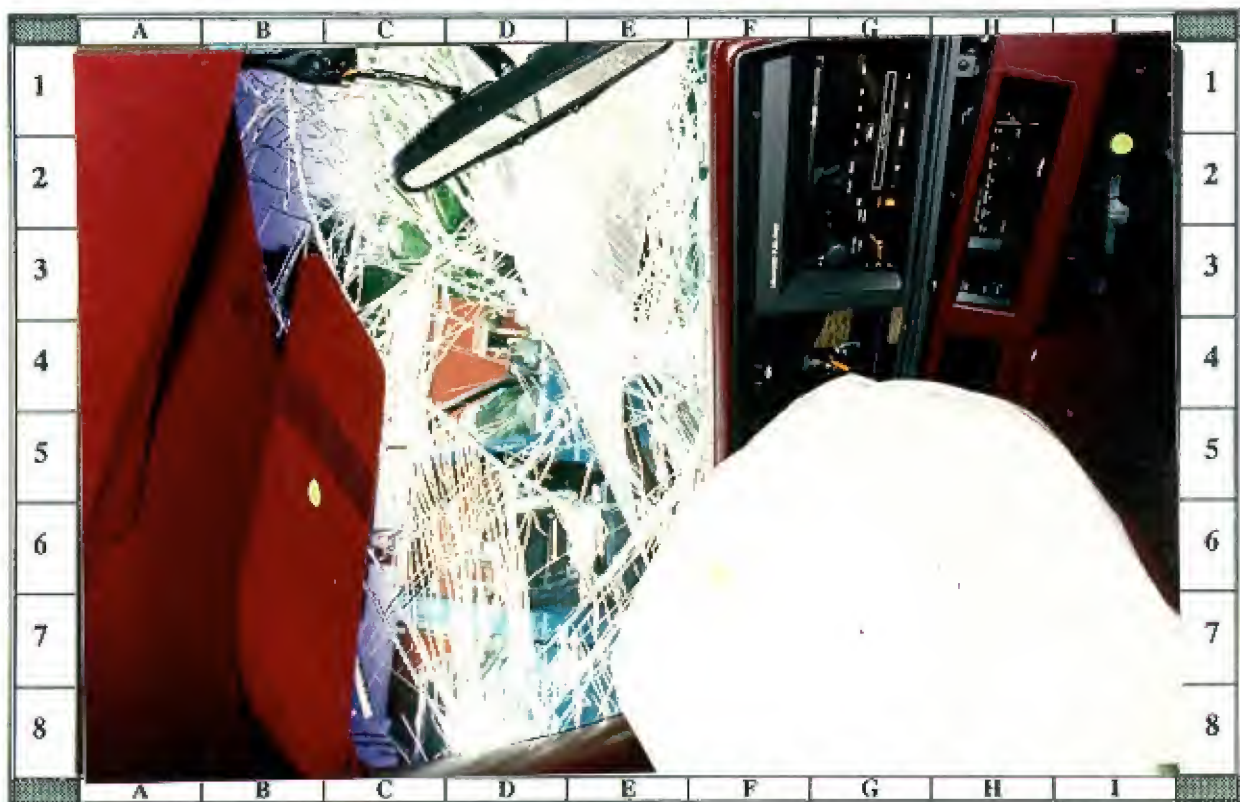
# 59 -- 1994 Oldsmobile's steering wheel and dash viewed from the right;  
NOTE: hair on sunvisor (cell B6) and dash indentation (cell F5)

Left lower dash panel broken out from right knee contact, hair on sunvisor, smudge on left dash, and deployed air bag (see **SELECTED PHOTOGRAPHS**, Photographs # 61, # 59, and # 60, pages 30-31)

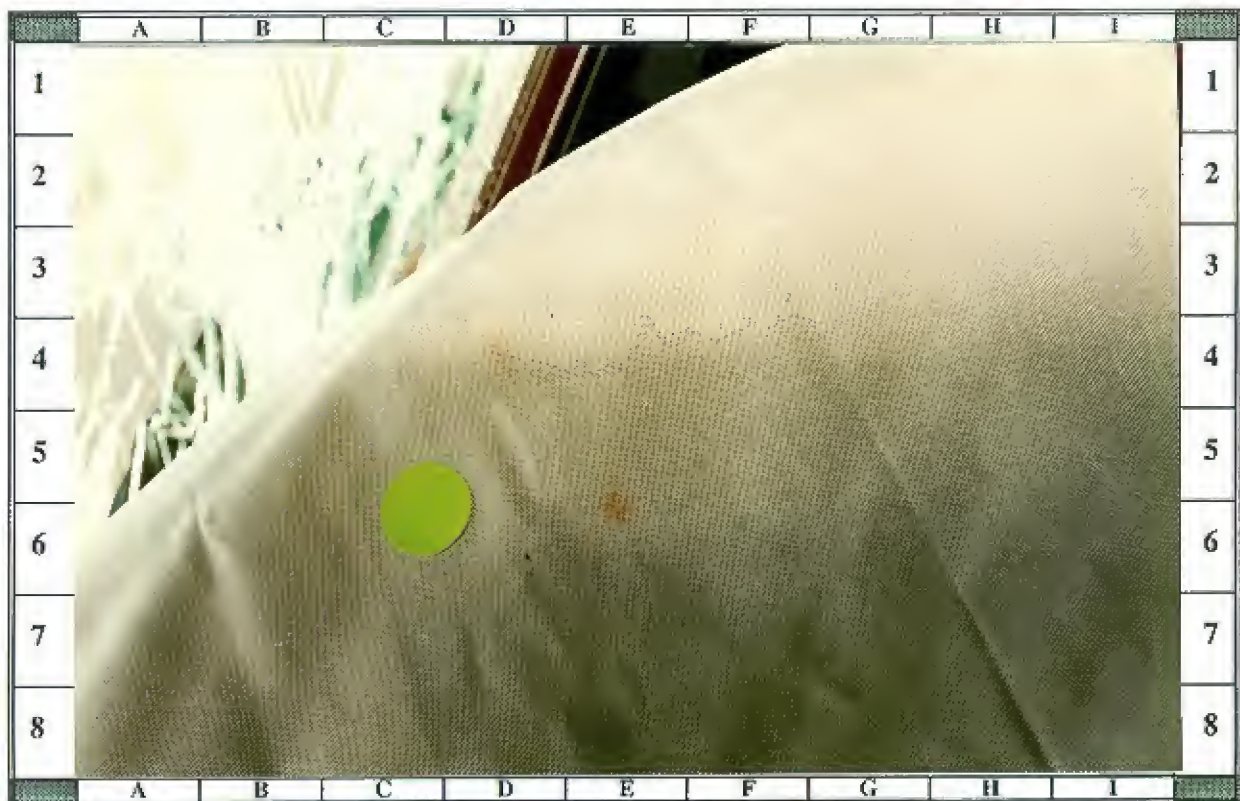
# 60 -- Close-up of probable facial contact to 1994 Oldsmobile Cutlass  
Ciera S's driver air bag

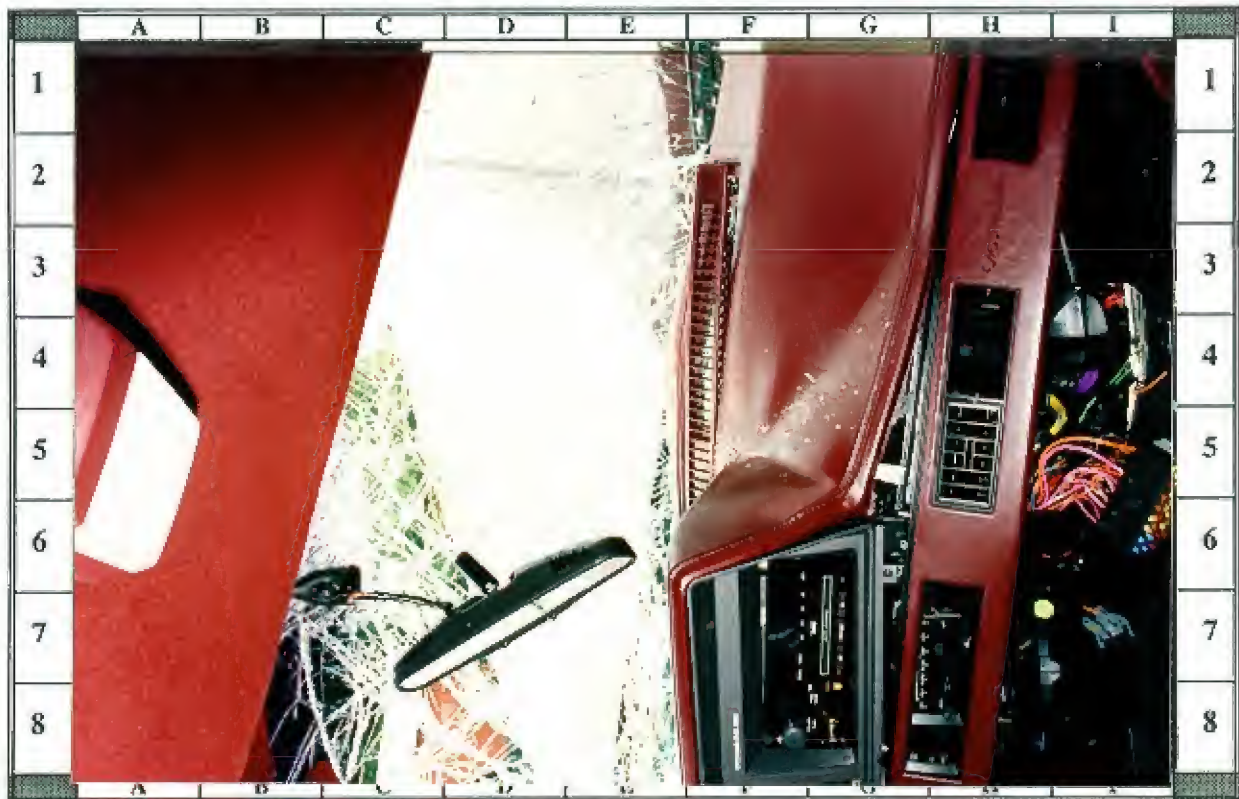
# 61 -- Close-up of 1994 Oldsmobile Cutlass's left & center dash; NOTE: dash damage, R knee contact (cells H6-I7), & rearview mirror

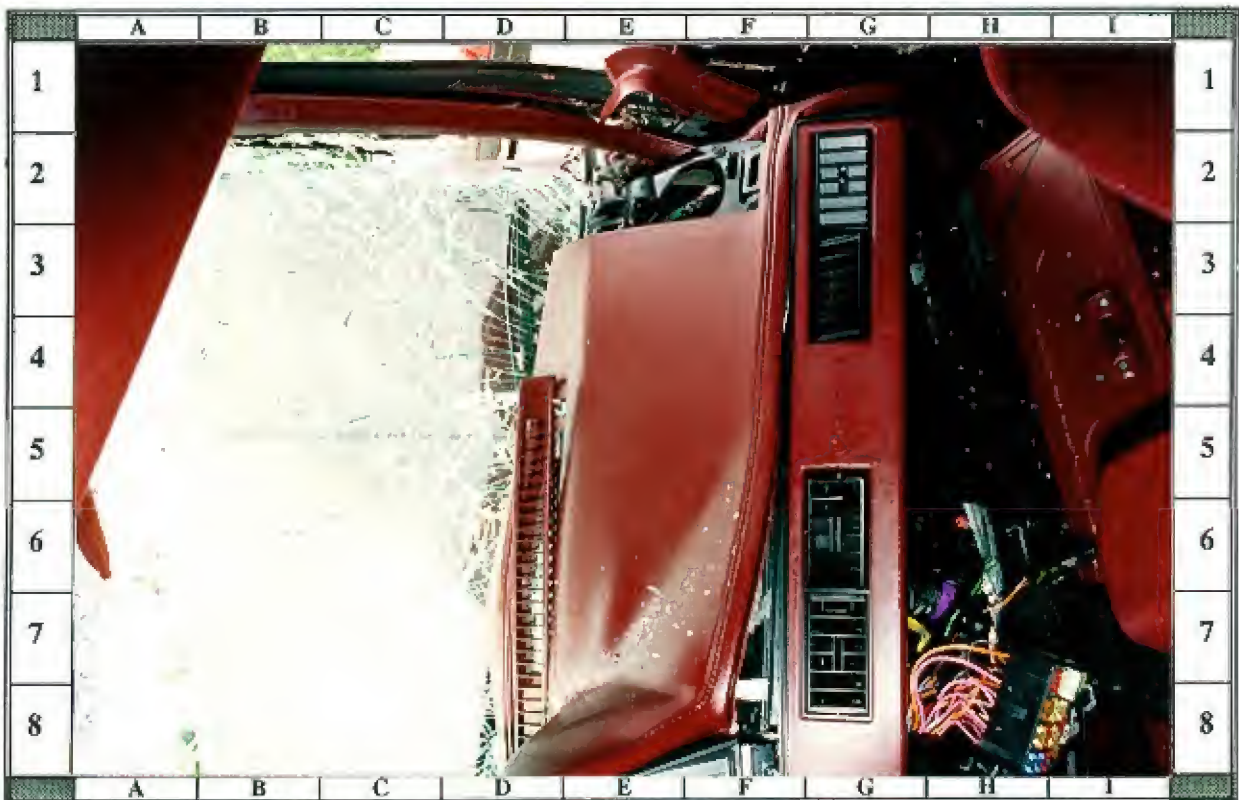
# 62 -- Close-up of 1994 Oldsmobile Cutlass Ciera S's right dash; NOTE: extensive dash intrusion & glove box & induced windshield damage

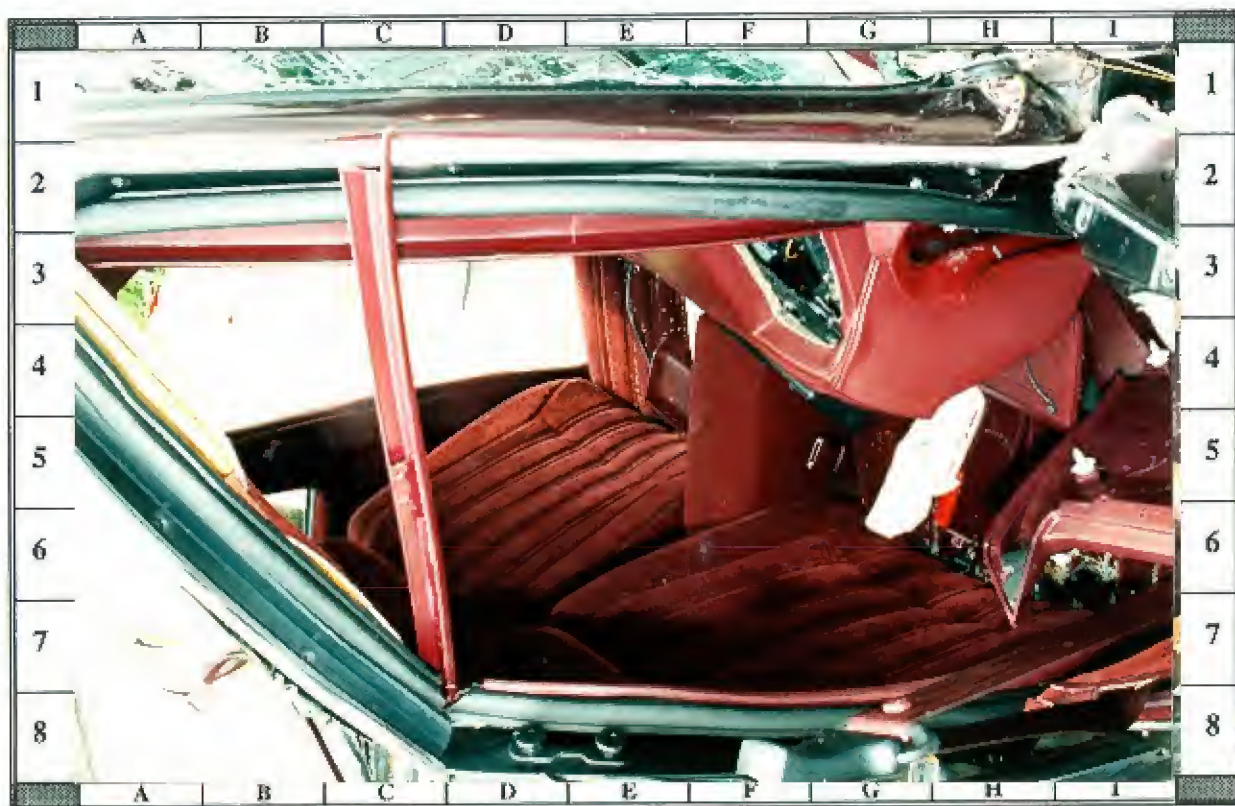
# 63 -- Front passenger seating area of 1994 Oldsmobile Cutlass viewed from right; NOTE: right A-pillar and intrusion into RF space

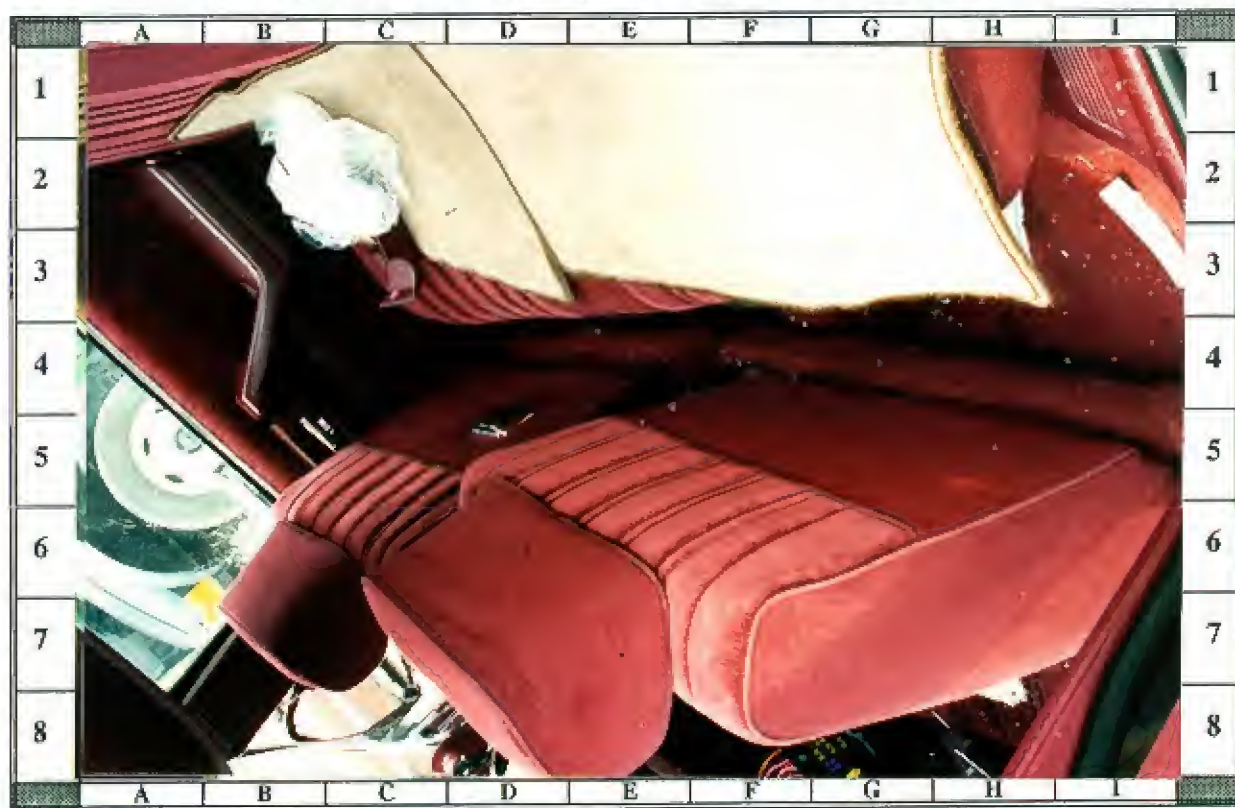
# 64 -- Rear passenger seating area & front seat backs of '94 Oldsmobile Cutlass; NOTE: RF seat intrusion into RR occupant's leg area
